## 支援事業活用事例のご紹介②

### ベトナム国「斜面災害予防ソリューション」 に関する案件化調査

奥山ボーリング株式会社 林一成\*, 鈴木聰

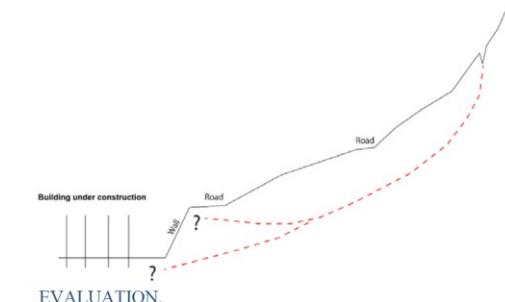
Figure 5. Estimated landslide's slip surfaces.

- Geology: Mudstone – Sandstone – Marls
- Slip surface: according to the width of the landslide about 300m, the depth of the slip surface is predicted about 20m-30m.
- The terminal part of the landslide is thought to be either in the middle part of the retaining wall or under the basement of the building under construction.
- Landslide's Origin: the large increment of groundwater due to torrential rain and the excavation of the mountain slope for building construction.

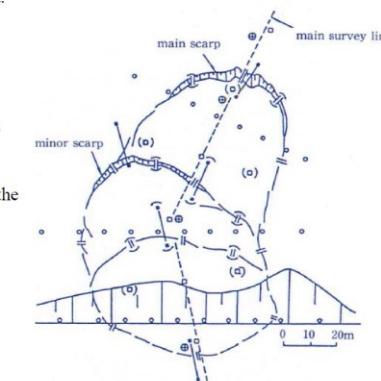
Figure 6. Example of instrumentation

- Ground water measurement
- Borings
- Subsurface strain measurement
- Inclinometer
- Geophysical logging
- Extensometer
- Simple deformation detection method (Boards)
- Tiltmeter
- Transverse survey stakes

- a. Emergency response:
  - OFF LIMITS during heavy rain.
  - Installation of extensometer to crack (3-4 units) and observation.
  - Transverse survey (stakes)- About Once a week.
  - Installation of rain gauge.
  - In some cases, install an alarm device on the extensometer, rain gauge.

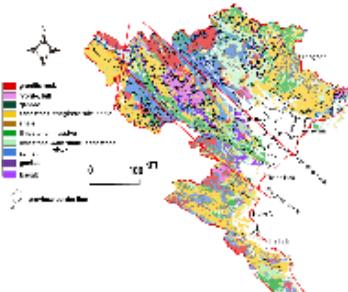
Fig.1 Geology and landslide distribution in northern

Figure 1 shows the distribution of landslides overlaid on the geological map of northern Vietnam reorganized into rock types. The landslides in the figure are shown by extracting 1927 points from the landslides collected by SFLP from 2012 to 2014. The figure shows that landslides occur throughout northern Vietnam.
